# INSPECTION REPORT

**ERF 2283,  
PEARLESS PARK EAST,  
KRAAIFONTEIN,  
WESTERN CAPE PROVINCE**

**Inspection Carried Out: 30<sup>TH</sup> of November 2024**

**Kobus Rykaart**  
NACHI #22040418  
Property Inspector (Property Inspect 4u)

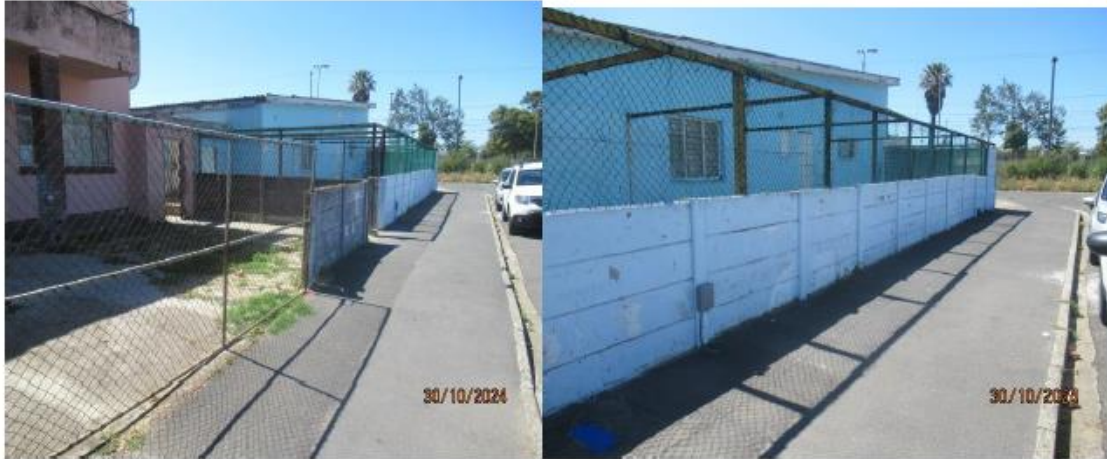
1. All the walls will need to be treated and decorated to refresh / upliftment.
2. The gates are generally functional but will require repairs and decoration.
3. The grounds can be cleaned up to refresh.

Wear seen on gates and walls.

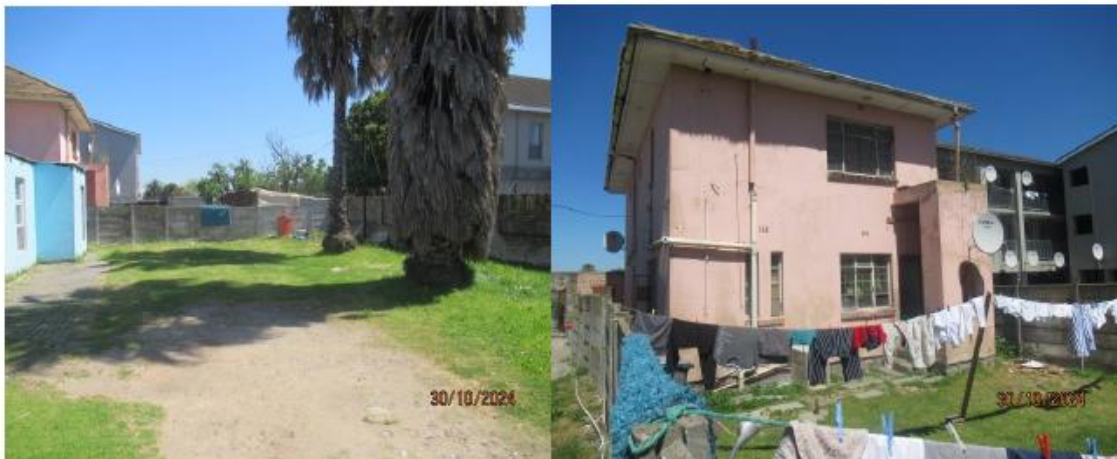
General condition of grounds.

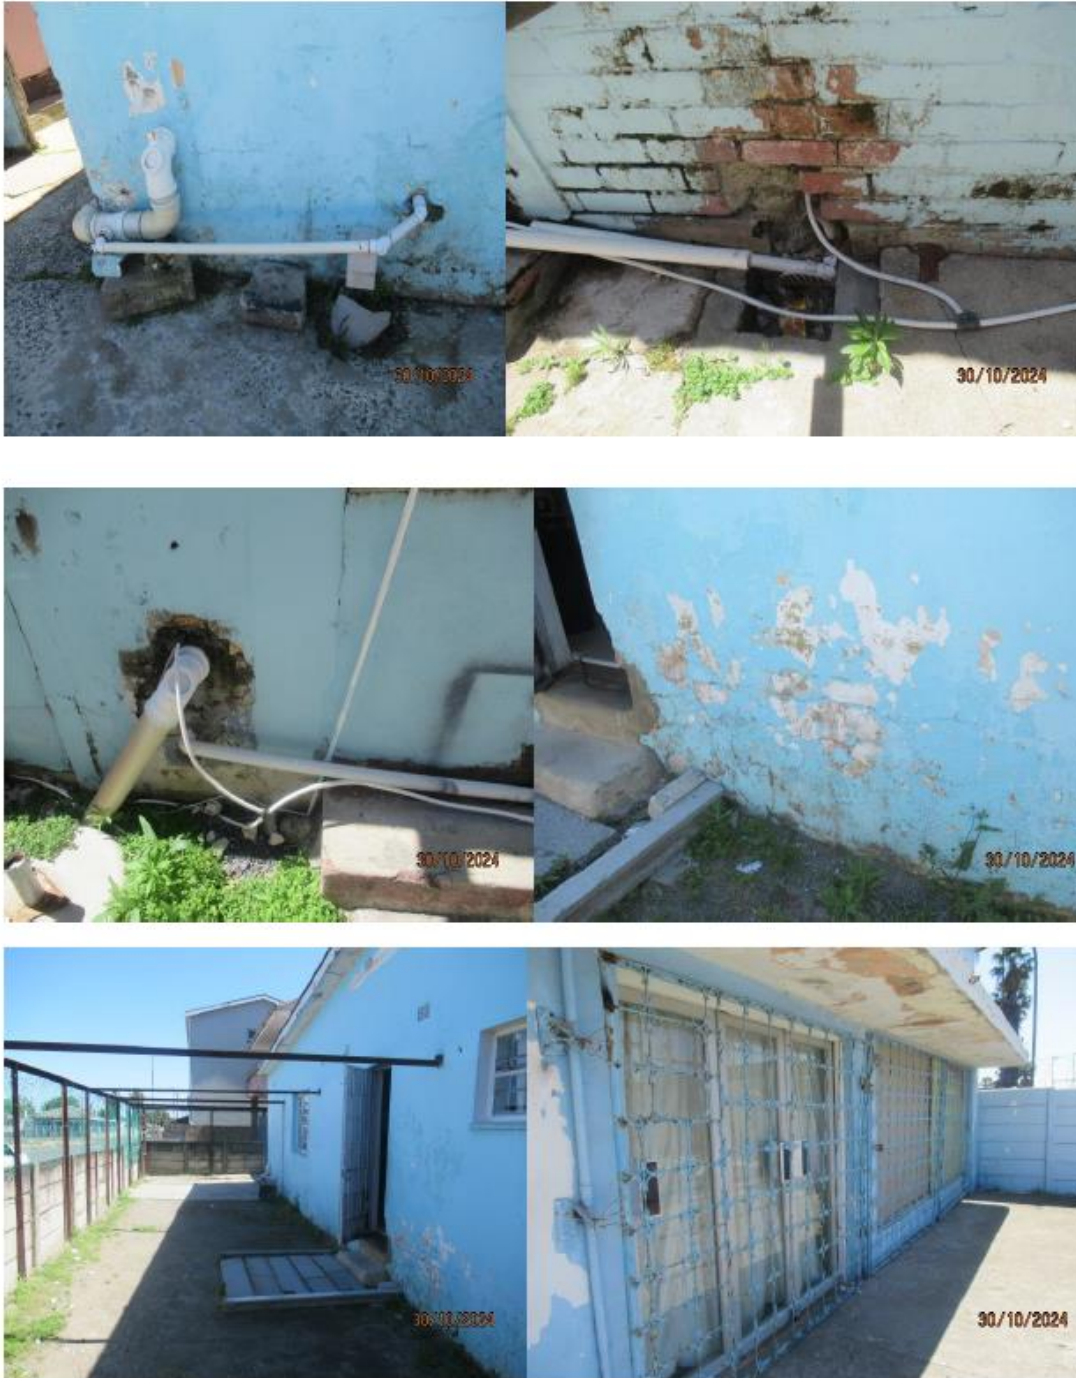
1. Multiple settlement and plaster cracks with various areas of exposed brick work, raw plaster work, unfinished plumbing etc. is noted on both buildings. These will all need to be repaired, brick up and plaster, metal stitching as needed on various surfaces.

General condition of church building.

2. All the walls and raw plaster will need to be high pressure cleaned and primed prior decoration on both buildings.

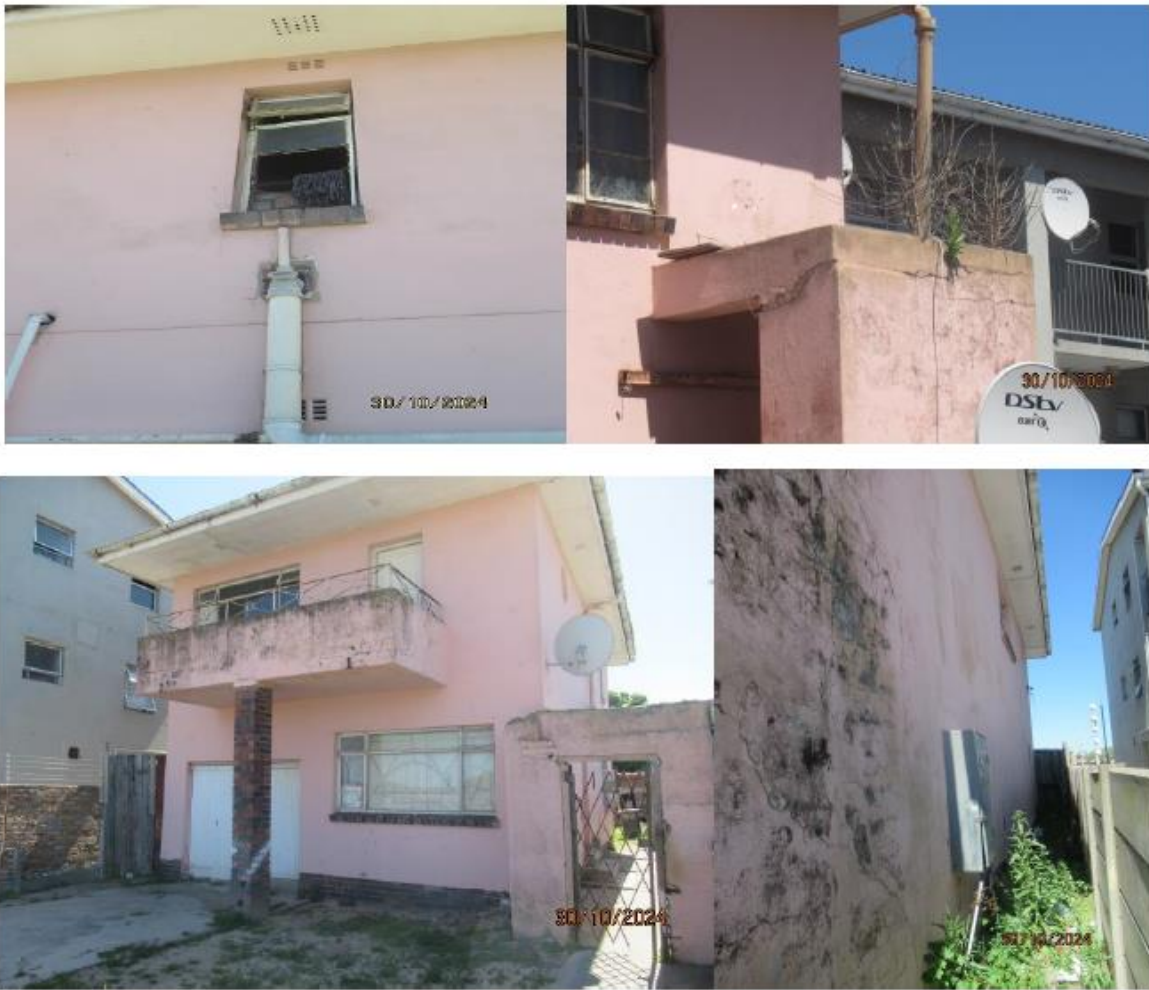
General condition of residential building.

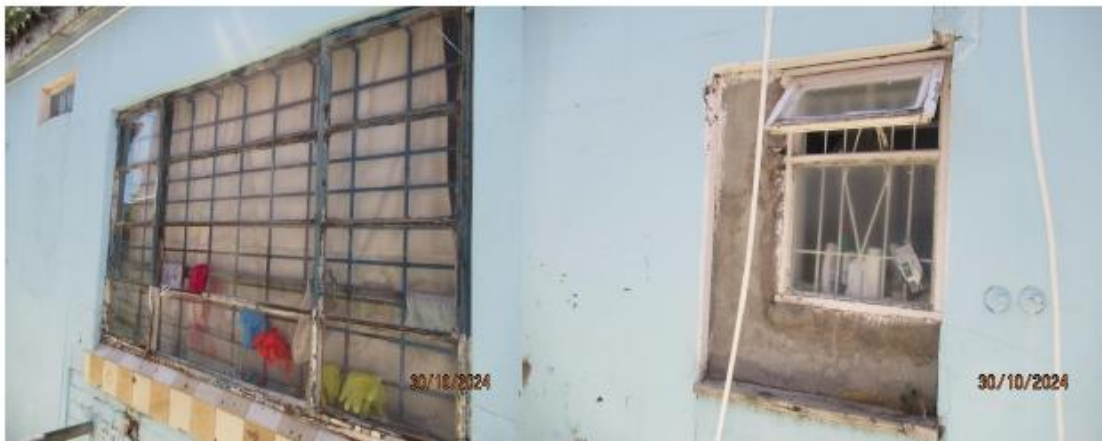
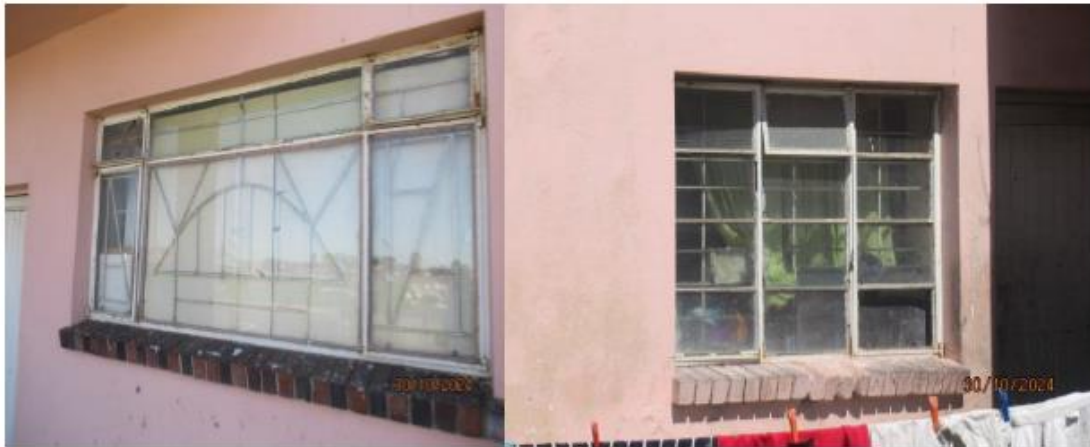
3. Multiple windowpanes are broken with corrosion seen on the windows and repairs needed to the majority to function with ease. All the glazing will need to be replaced, the windows repaired and corrosion treated prior decoration.

General condition of windows.

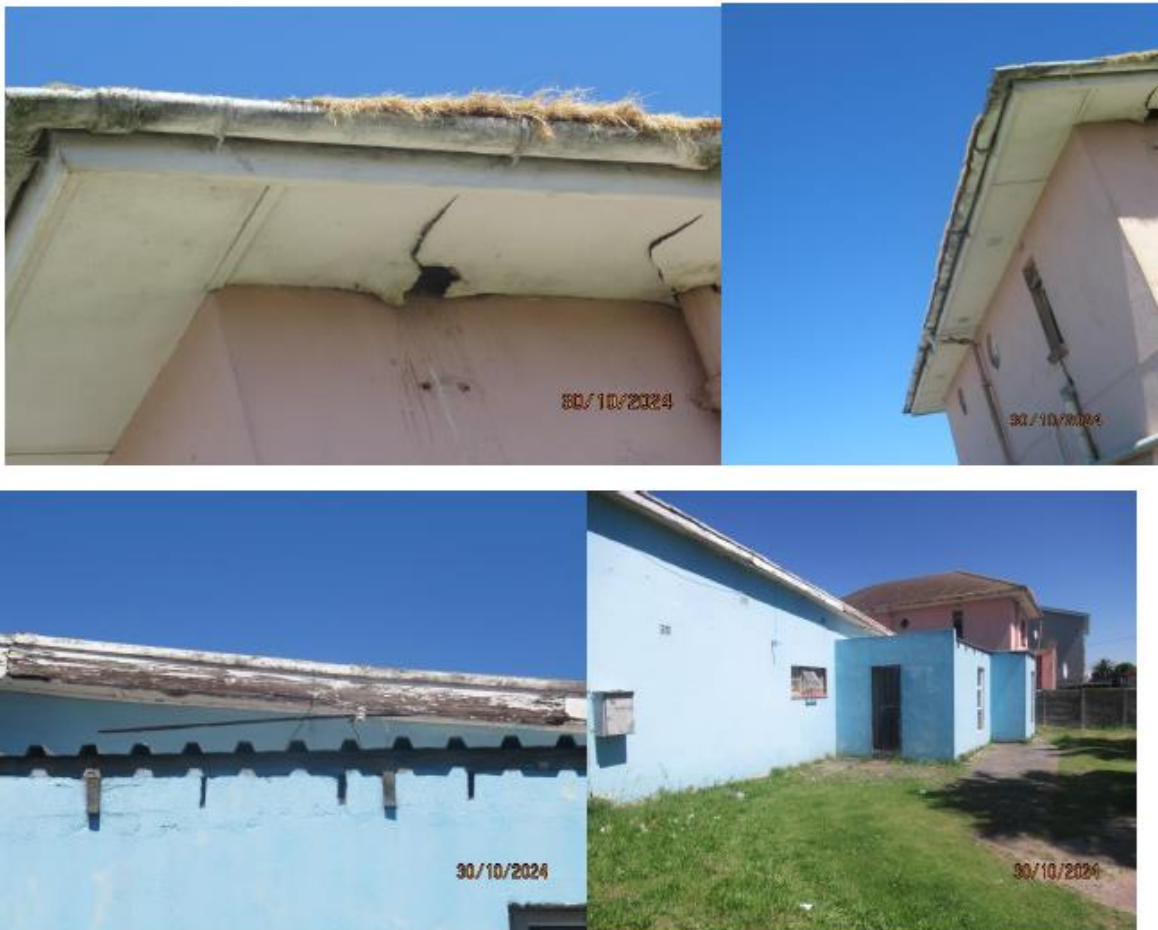
4. The eaves and fascia boards on both buildings show excessive wear, damages in some cases and rot in others. The rotten fascia boards will need to be replaced, damaged eaves repaired and all treated and decorated.

General condition of eaves and fascia boards.

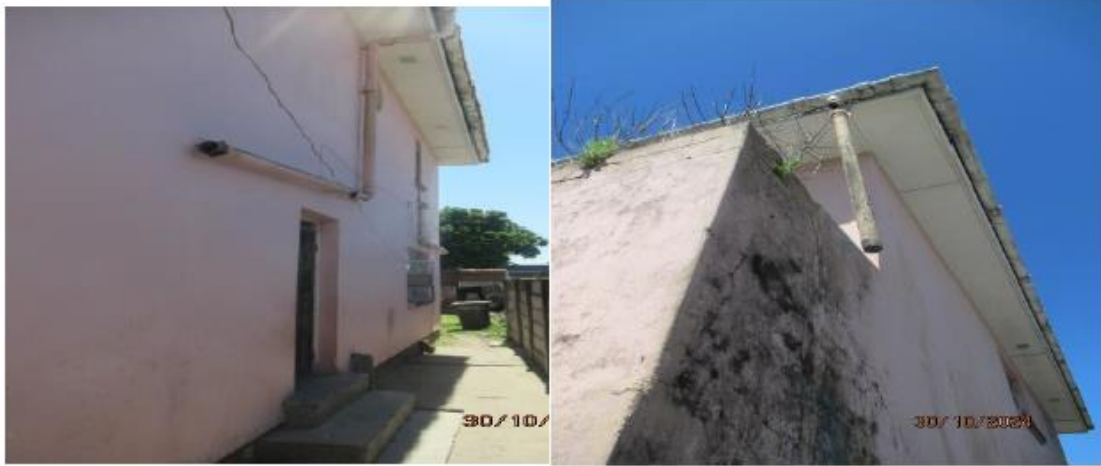
5. The asbestos gutters on the residential areas show excessive wear, these areas would need to be cleaned and sealed to joins. Various downpipes have been dislodged, these will need to be replaced.
6. The gutters on the church have dislodged, these will need to be replaced.

Examples of broken downpipes.

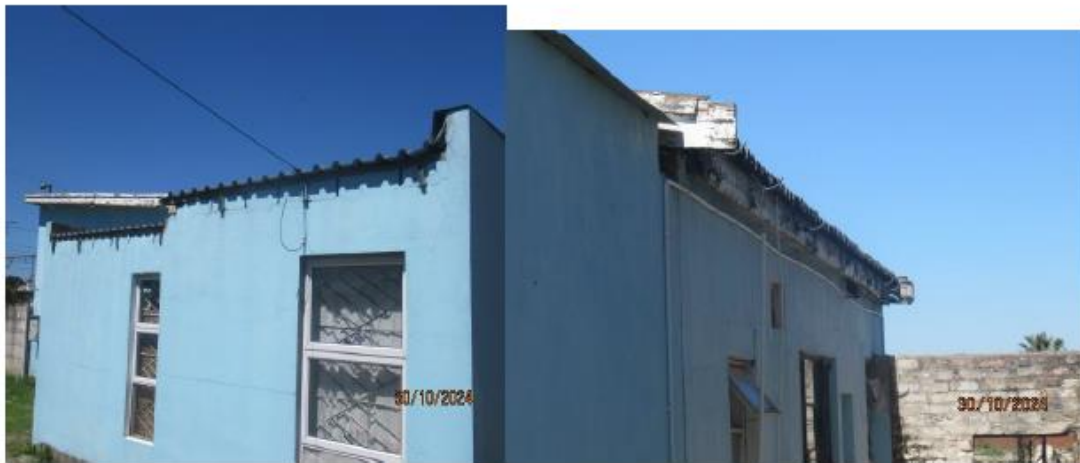
No gutter on church.

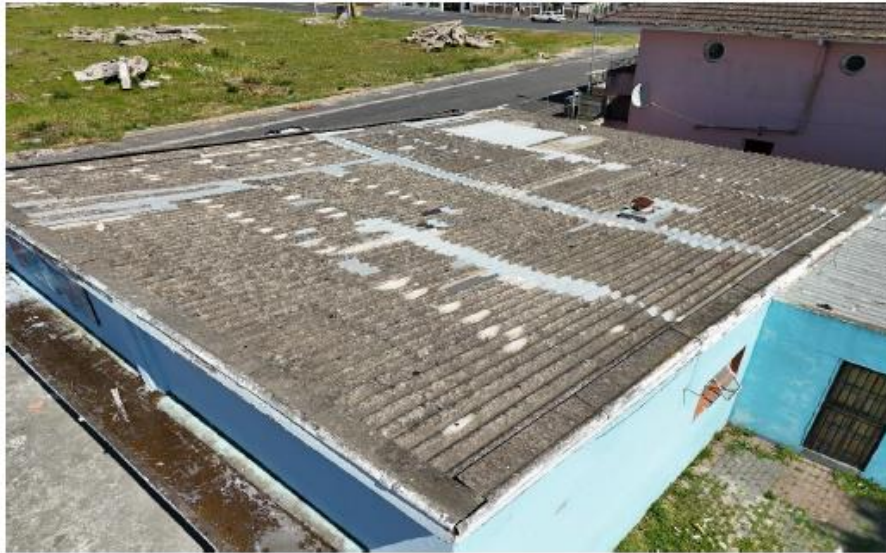
The flat roof on the church is asbestos sheeting, this is sagging to the degree of concern, the asbestos is of age and shows multiple repairs. A concern is that there is no access to the bearing beams and therefore the condition cannot be established.

General condition with multiple repairs.

1. Here, the asbestos roof sheets show multiple repairs and sagging. One can continue to repair; however, I do not feel this will be cost effective and replacement with metal sheeting is a solution.
2. Once the sheeting is lifted, the bearing beams can be expected and either levelled, additional supports installed or replaced as needed. This is a hidden cost.

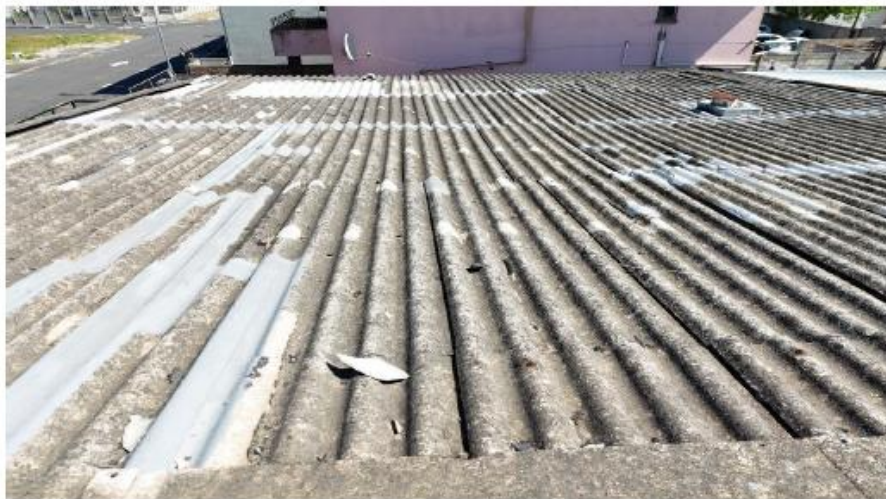
Bowing seen on roof.

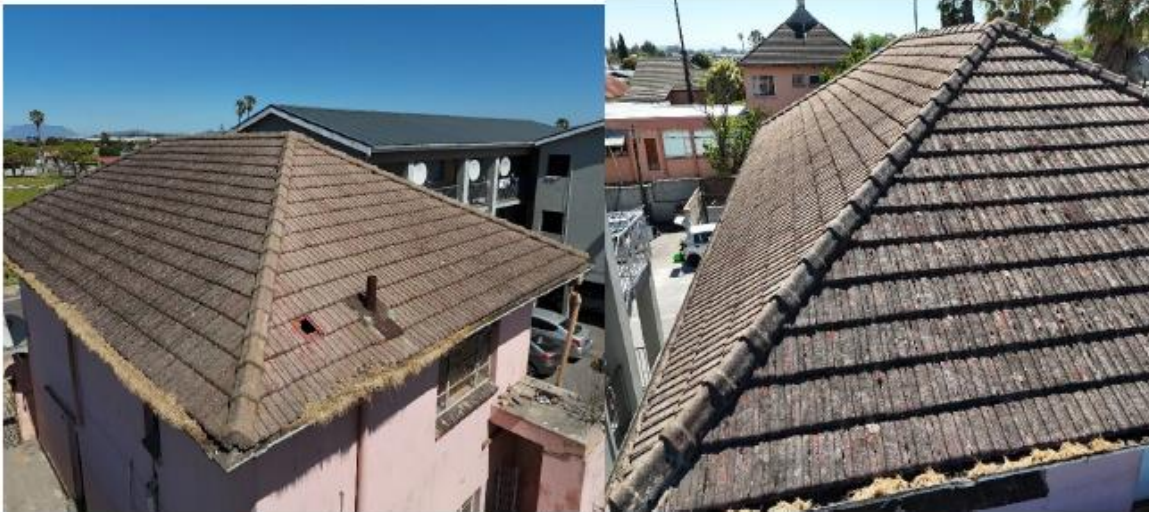
The pitched roof covered with a cement tile on the residential area can be restored but will need excessive work. Here, cement caulking, cleaning of algae, repairs and replacement on the roof tiles are needed.

Roof showing strong level lines with excessive wear.

1. Replace all cracked and chipped tiles and cement caulking on the ridge capping, this will ensure that all areas are watertight.
2. A build-up of algae is noted and this will need to be high pressure cleaned.

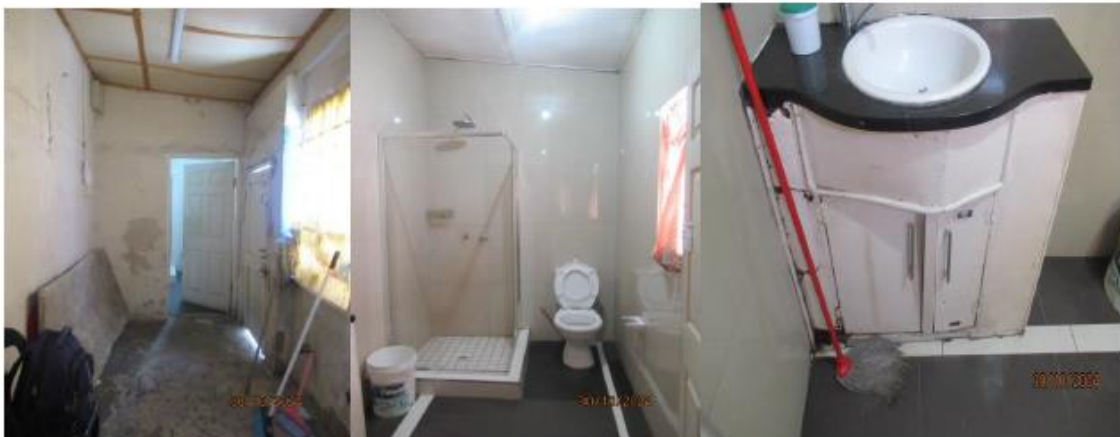
General condition of spaces.

1. Replace vanity unit in bathroom due to water damage.
2. Treat and decorate all walls, ceilings, windows and doors.

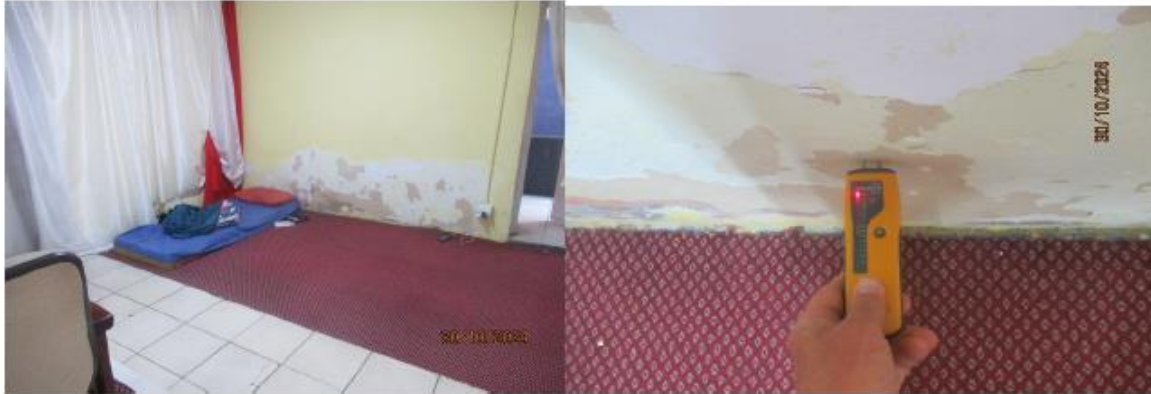
Area of rising damp with high moisture.

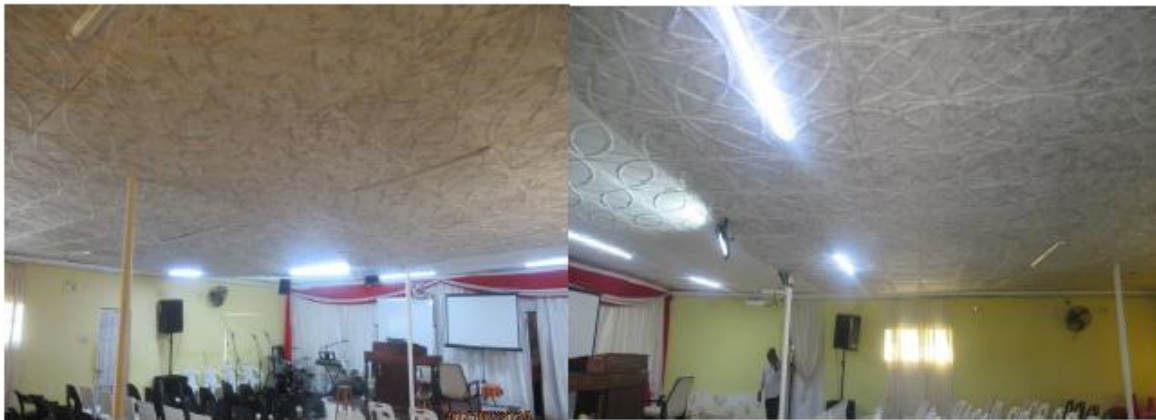
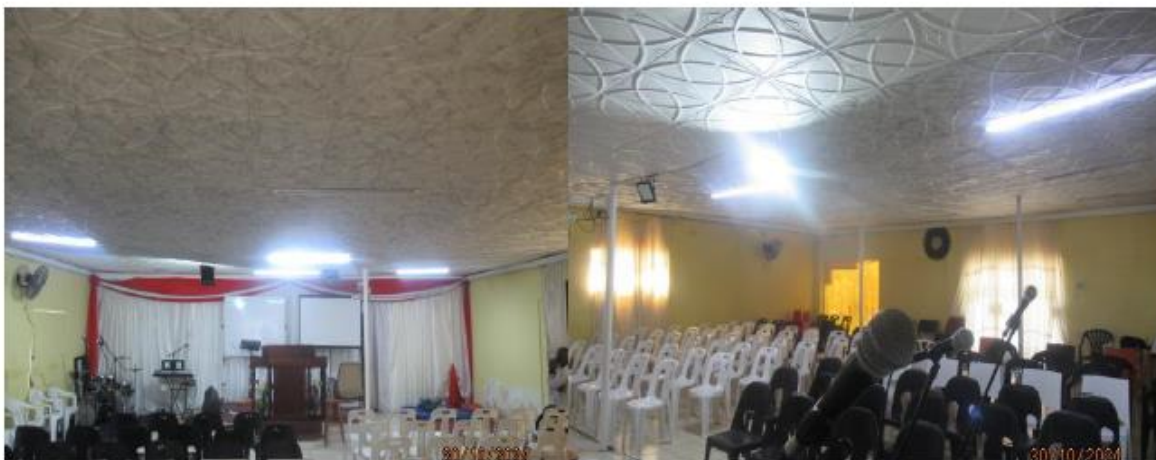
1. Rising damp is noted in the North-East corner of the church. This will need to be repaired by a specialist.
2. The ceiling of the church is bowing extensively and I suspect this is a hazard as it can dislodge due to the severity of the condition. I suspect the ceiling boards have pulled loose from the bracing or the bracing broke loose from the trusses, I suspect the bowing of the roof is also contributing to this effect. Either way it will need to be replaced. I do not suggest activity in this area until the ceiling is secured or replaced.

Ceiling bowing extensively.

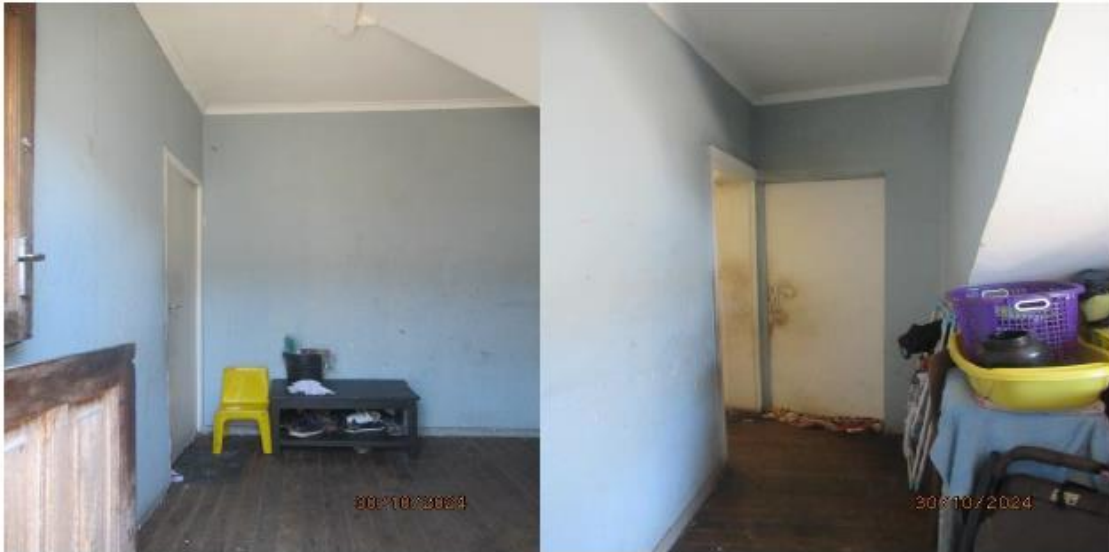
General condition of space.

1. The wooden floors show wear and have not been treated for many years. This will need to be sanded and sealed.
2. The walls, ceilings, doors and windows all show excessive wear, they will require treatment and decoration.

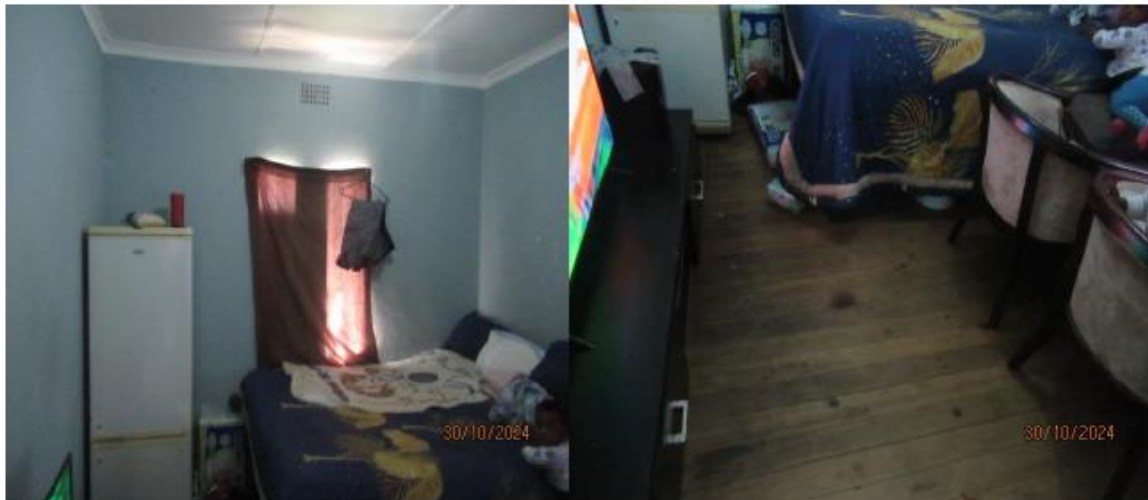
General condition of space.

1. The floors show excessive wear, sanding and sealing is required with repairs.
2. The walls, ceilings, doors and windows all show excessive wear, dirt and debris. They will all need to be treated and decorated.

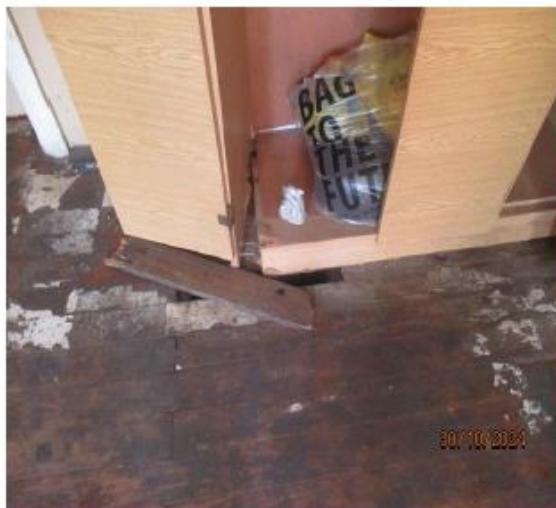
Hole on floor and condition of floor.

1. There is a hole on the floor and the floor shows excessive wear. The hole will need to be repaired and the floor sanded and sealed.
2. All the walls, ceilings, doors and windows show excessive wear and a lack of maintenance. They will all need to be treated and decorated.
3. The built-in cupboard units are in a poor state, I suspect the cupboards could possibly be restored, however the countertops will need to be replaced due to water damage.

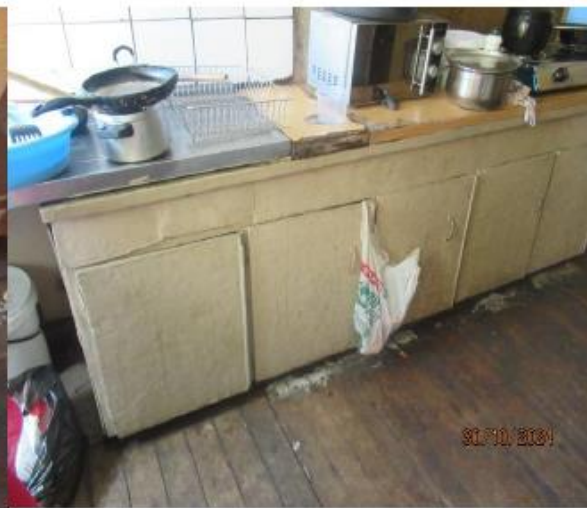
Condition of built-in cupboard units.

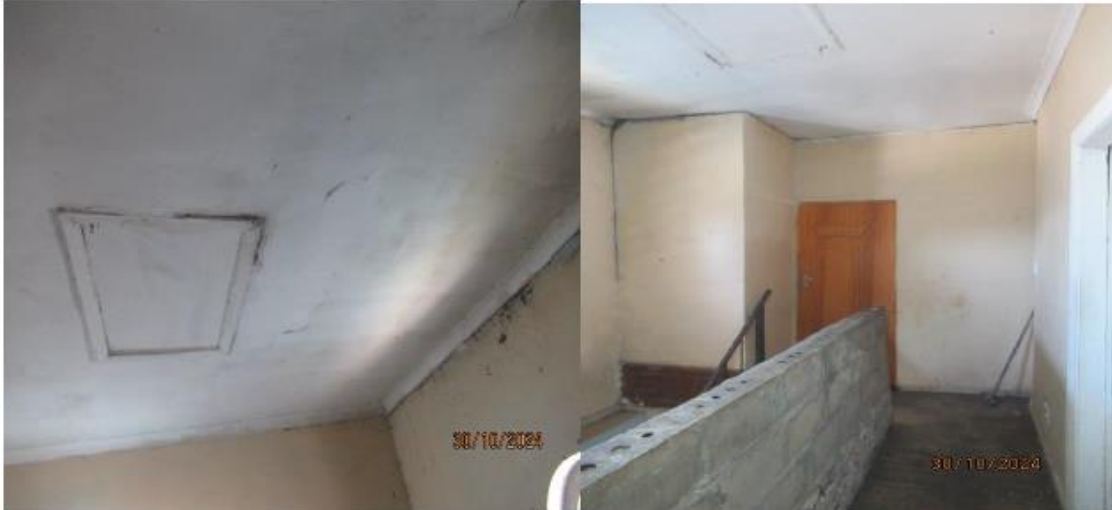
Damage on ceiling and general condition of space.

1. The wooden floors show excessive wear and they can be sanded and sealed. The concrete stairs can be cleaned and decorated.
2. Impact damage is noted on the ceiling above the staircase, this can be repaired, treated and decorated.
3. Excessive wear, debris and dirt is noted on the walls, doors and windows. All these areas will need to be treated and decorated.

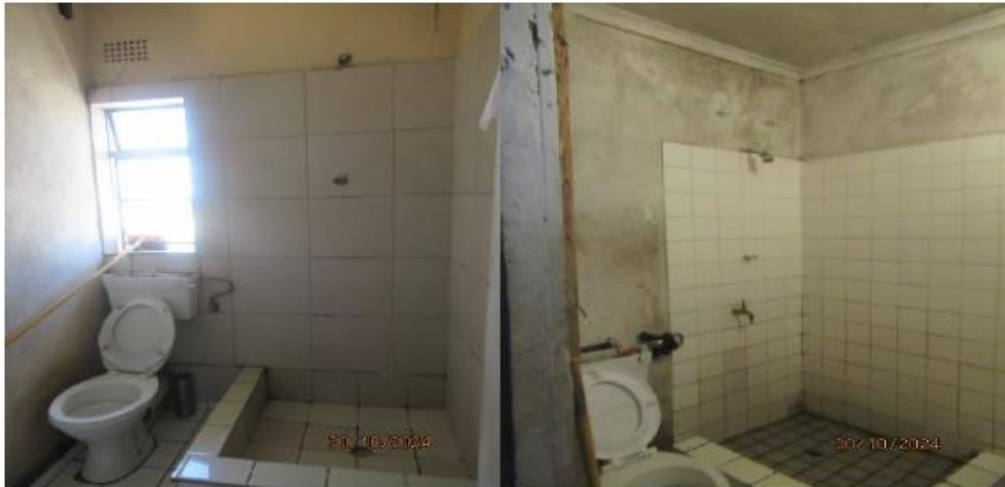
First bathroom.

Second bathroom.

4. The bathrooms show wear, the walls and ceilings will need to be treated and decorated.
5. The first bathroom shower rose needs replaced with rails and a curtain installed.
6. The second bathrooms shower is functional but requires rail and curtain.
7. No allocation for hot water is seen to the showers.
